REPORT NO. 91-14

WOODEN BOX PALLET
MIL-STD-1660 TESTS

Prepared for:
U.S. Army Defense Ammunition
Center and School
ATTN: SMCAC-DES
Savanna, IL

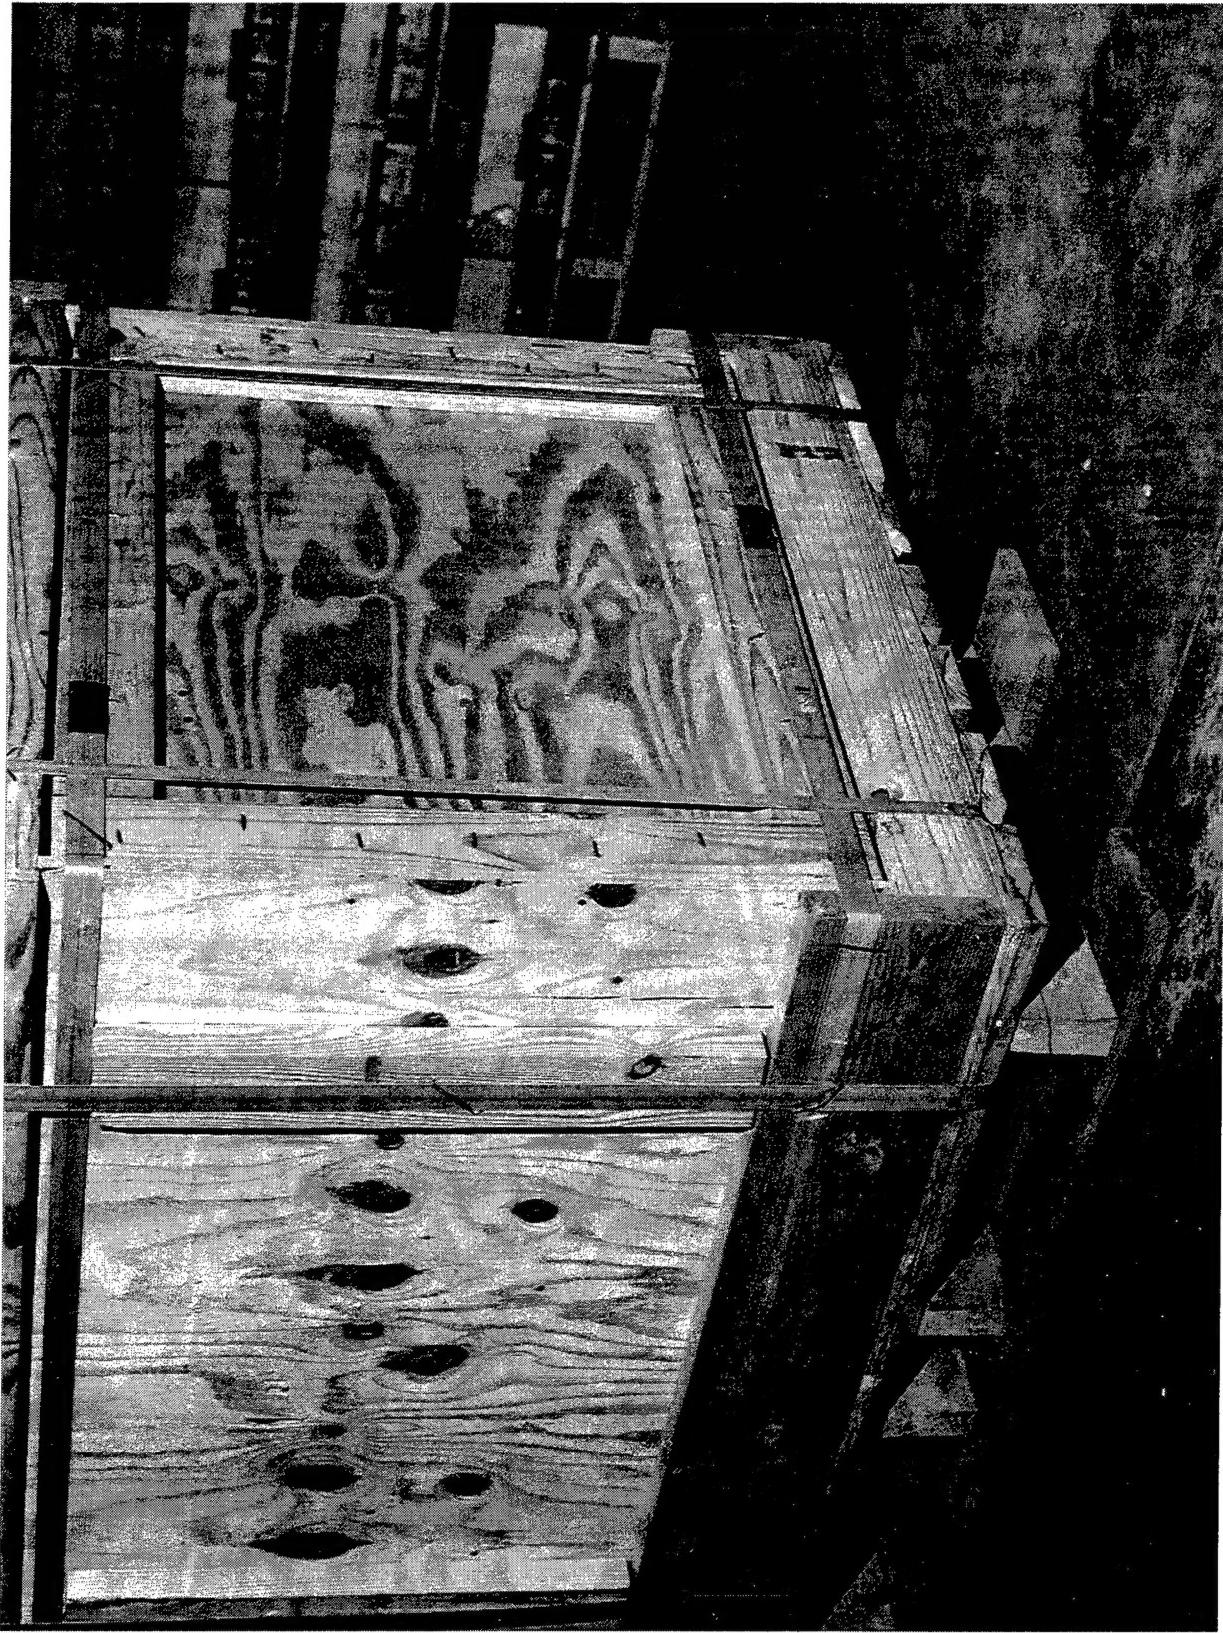
3. EDGEWISE ROTATIONAL DROP TEST. Each side of the pallet base was placed on a beam displacing it 4-1/2-inches above the floor. The ends of the pallet were raised to a height of 24 inches, which is 12 inches higher than required. The process was repeated in a clockwise direction until all four sides of the pallet had been tested. The damaged band from the repetitive shock test broke during the first drop. Testing continued with no other damage.

AO317-SCN-96-123-2383. This photo shows the damaged side of the second pallet. Note the broken band and cracking of the rear plywood face.
